CIVIL AERONAUTICS BOARD

ACCIDENT INVESTIGATION REPORT

UNITED AIR LINES, INC., NEAR OAKLAND, CALIFORNIA, AUGUST 24, 1951

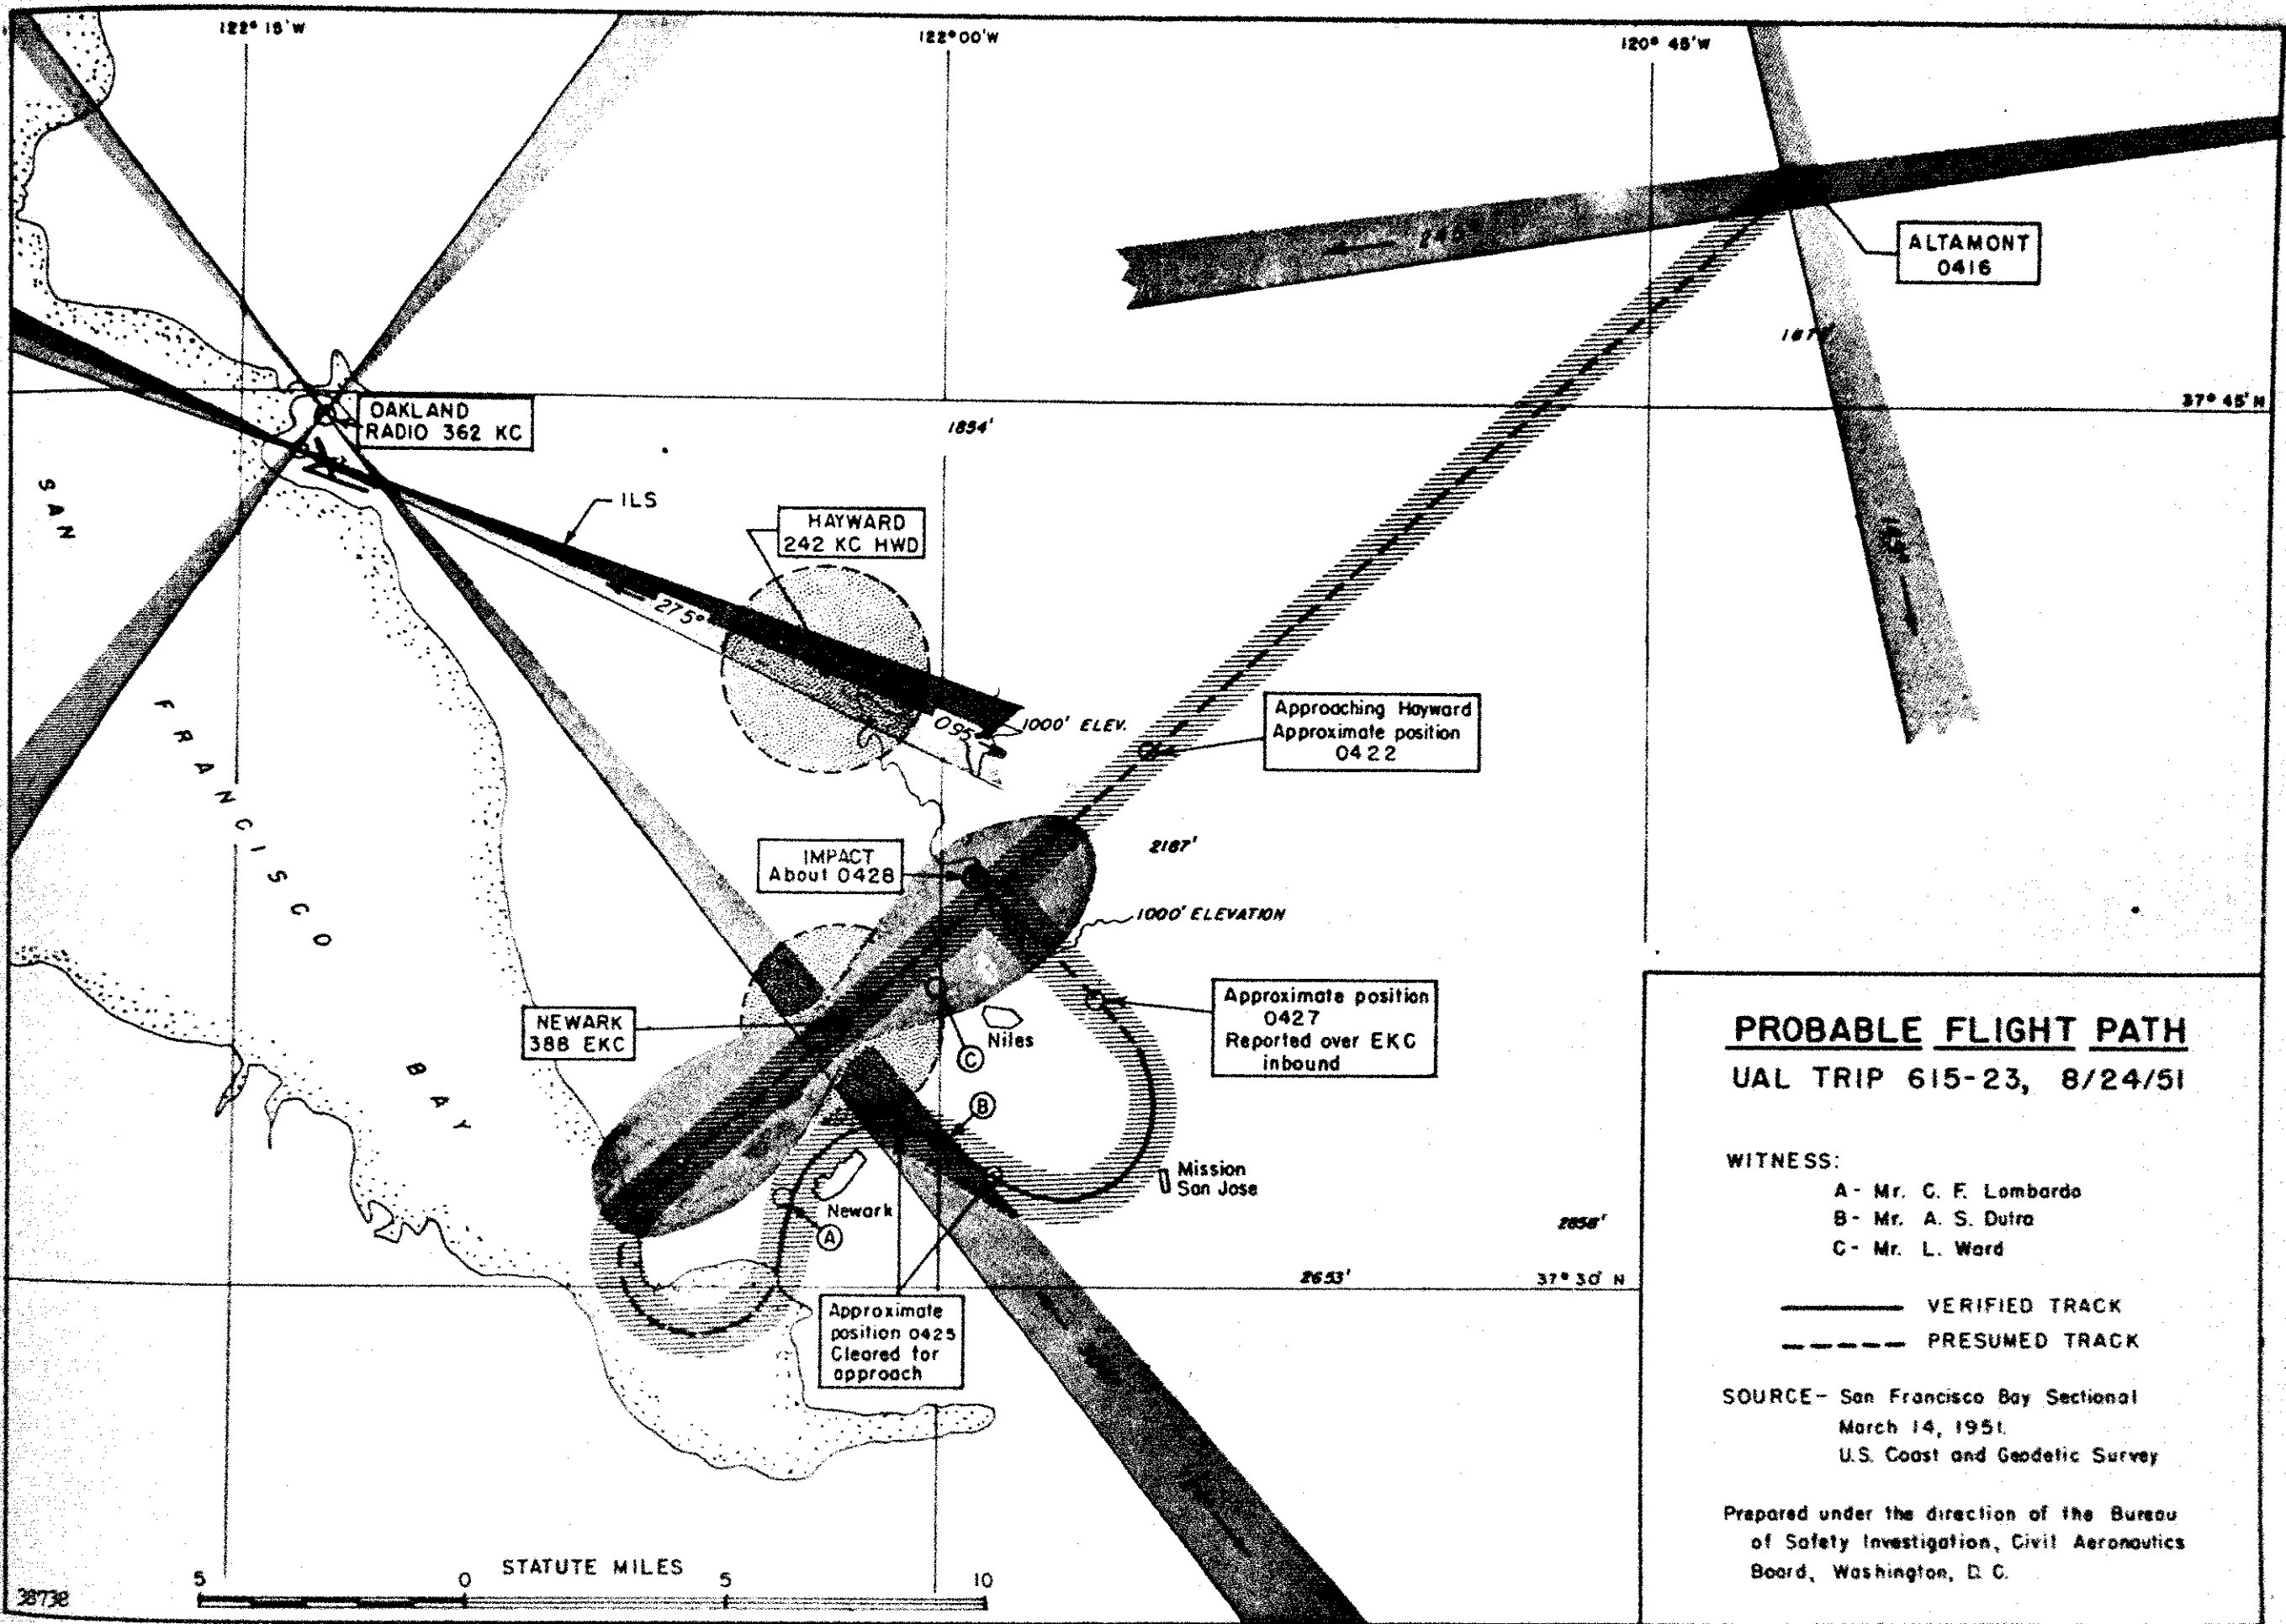
PROBABLE FLIGHT PATH

It should be noted that all witnesses stated the aircraft was flying at low altitude in the Newark area and reconstruction of the flight path indicated the altitude was in the neighborhood of 1,500 to 2,000 feet prior to the final, straight descent. It has been pointed out that the flight was still on an IFR flight plan at the time it crashed, and the minimum prescribed altitude prior to leaving Newark is 3,500 feet. Flight 615 was neither at least 500 feet above the top of the stratus layer nor adhering to the minimum altitude of 3,500 feet as it maneuvered awaiting clearance to Oakland. Witnesses reported that it was below, or just skirting, the lower side of the clouds.

Had the flight proceeded on the course indicated by the probable flight path, it would have passed near the Hayward compass locator. The theory has been advanced that the pilot flying was partly in contact and was using the first officer's ADF needle as a course check. The volume control on this unit was found in the OFF position, and it is possible that the pilot thought the receiver was tuned to the Oakland radio range station. Had the volume control been turned up and the vital aural check on station identification and range been made, the pilot would have known immediately that the flight was not on-course inbound to Oakland. The needle indication alone will not show an aircraft's position relative to the range course.

A radio transmission was made by the flight one minute before the accident, advising that it was leaving Newark inbound. Final letdown to 500 feet is permissible past that point, and according to the last witness, the aircraft was descending during the time it was in his view. Plotting back one minute from the crash site, using the probable speed of the aircraft it is noted that the flight would have been slightly to the east of the town of Niles at the time the transmission was made. Niles could readily be confused with Newark under conditions of restricted visibility such as obtained at the time. The main section of Newark lies slightly to the left of the southeast course of the Oakland radio range, and occupies the same relative position with the southeast course as does Niles with the probable flight path.

The final left turn near Mission San Jose cannot be explained by any of the instrument procedures in force. By turning left from a southeast heading to northwest, the pilot may have planned to intercept the Oakland southeast course and proceed inbound. However, it will be recalled that neither of the two available radio range receivers was tuned to the Oakland radio range frequency. This turn, it is believed, was begun at about the time the flight was cleared by Approach Control for a straight-in approach.
